NASA TM -86529

COMPUTED TOMOGRAPHY FOR NON-DESTRUCTIVE EVALUATION OF COMPOSITES: APPLICATIONS AND CORRELATIONS

By B. Goldberg, L. Hediger, and E. Noel

Materials and Processes Laboratory
Science and Engineering Directorate

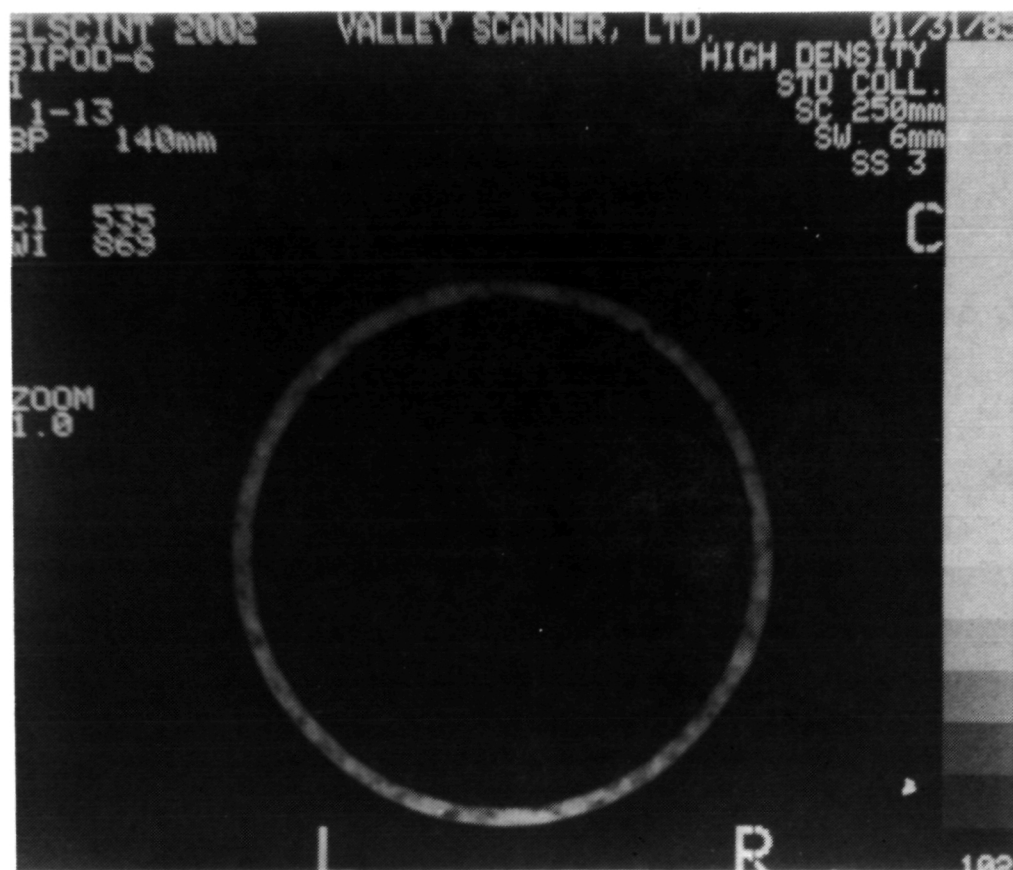
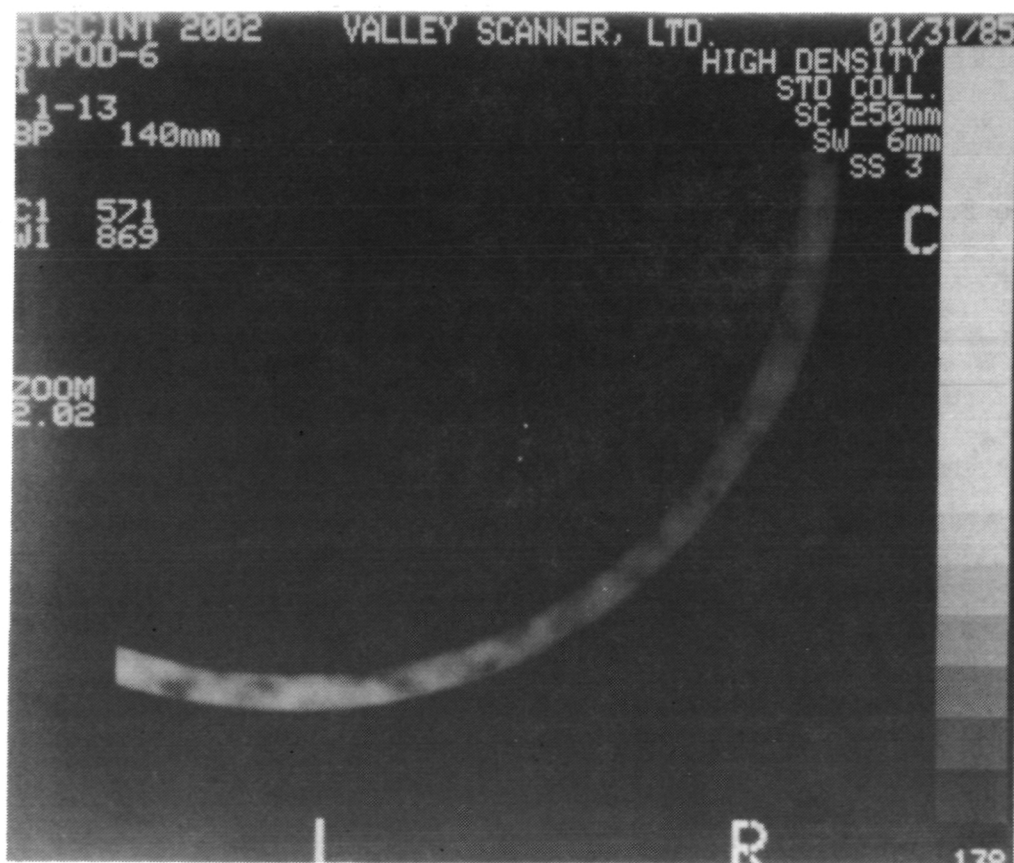
The second goal of the GEBS assessment was the determination of the applicability of CT to graphite epoxy components. CT data was found to provide more meaningful information than tangential RT data (Figs. 3 and 4). CT provided data taken over the entirety of the object as opposed to RT selective angular location approach and data with superior contrast and clarity to RT data. Further, CT appears to be less directionally sensitive than RT.

Figure 3. CT of GEBS. (a) Typical CT slice for GEBS. Note internal density variations. (b) Magnified view of three o'clock to six o'clock region from (a). Note void at four o'clock position.

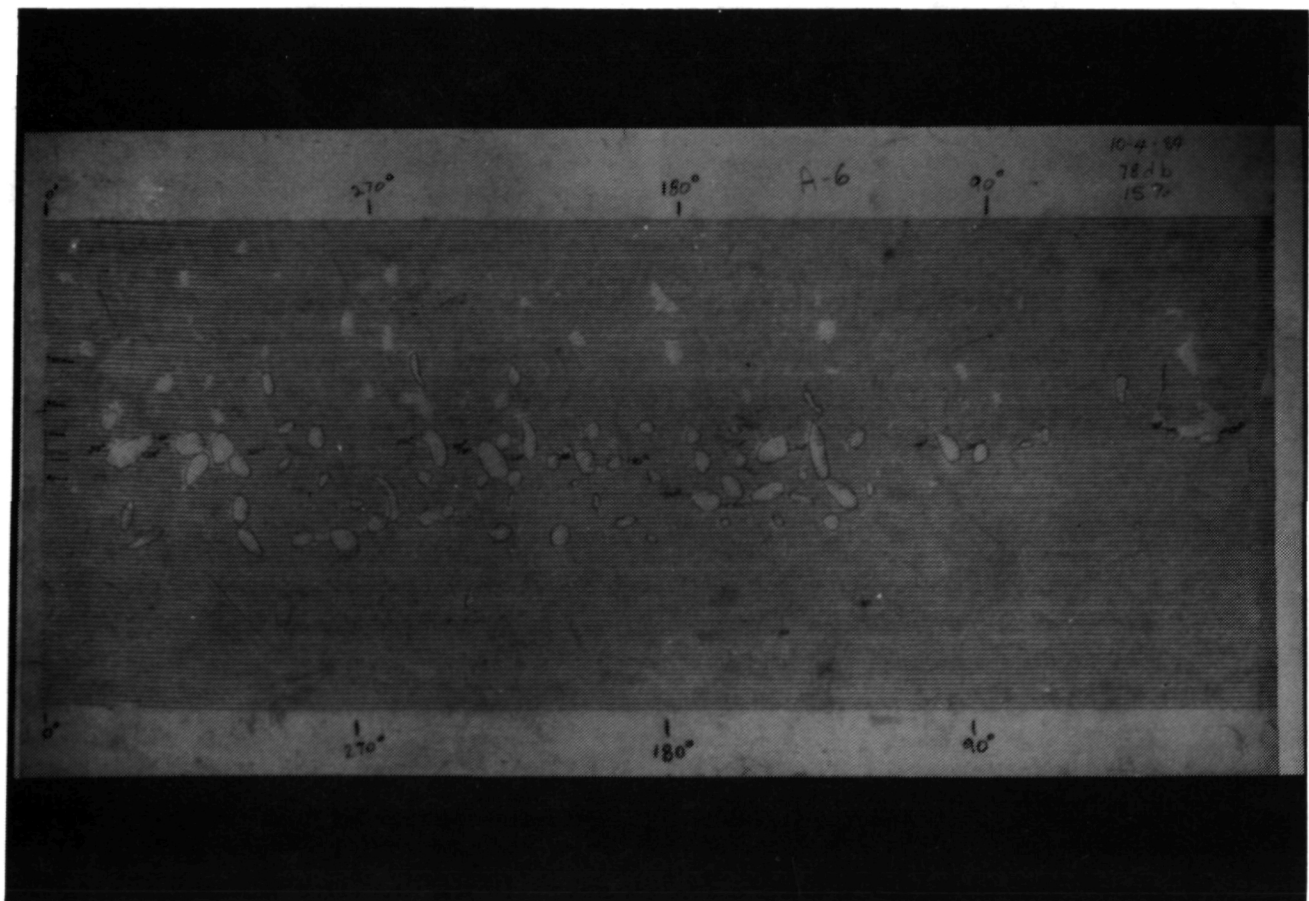
Figure 5. UT of GEBS. (Ultrasonic C-scan displays numerous delamination-like conditions in tapered wall region.)

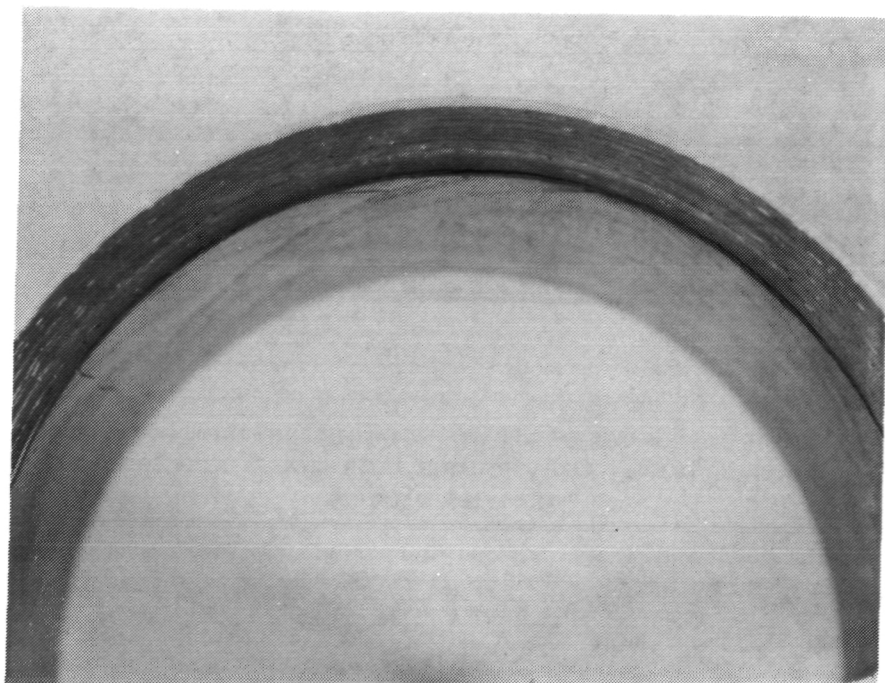
Figure 6. Delamination in GEBS. (Delamination visible through cylinder ID.)

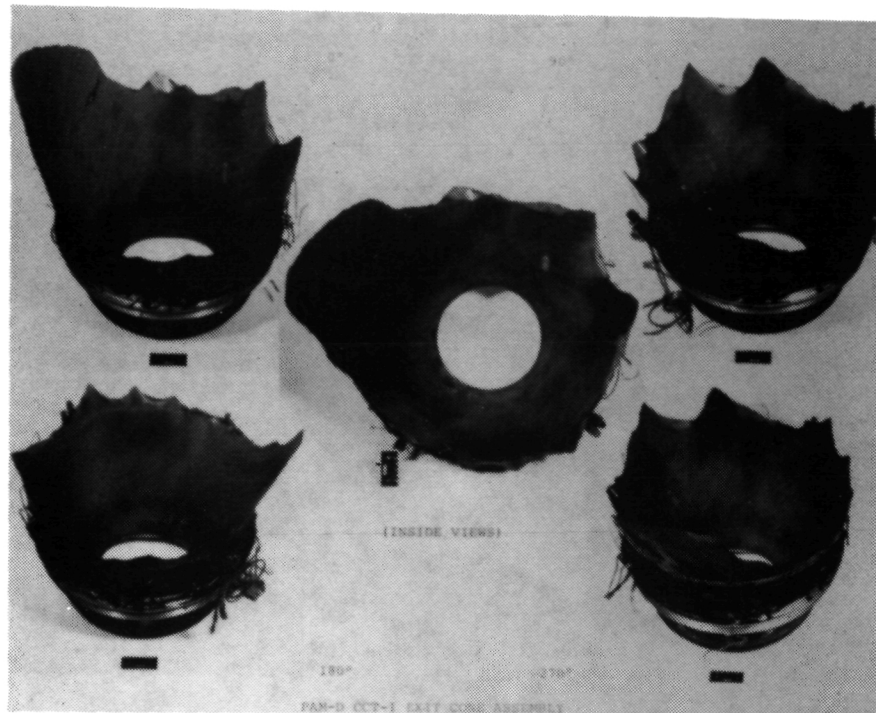
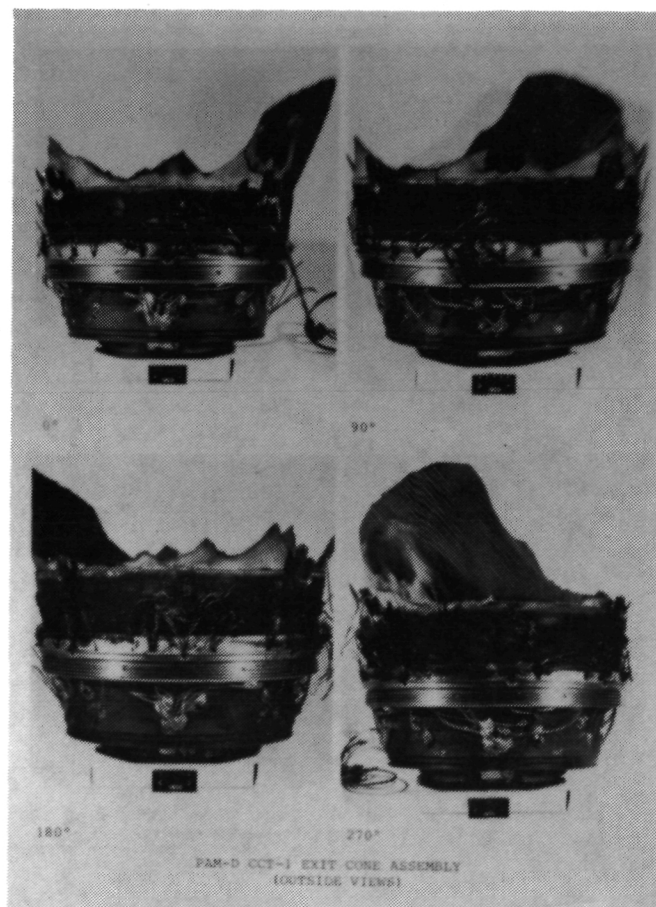
Figure 7. CCT-1 exit cone assembly. (a) Interior of carbon-carbon exit cone. Truncated cone due to sea-level induced buckling aft of insulator.

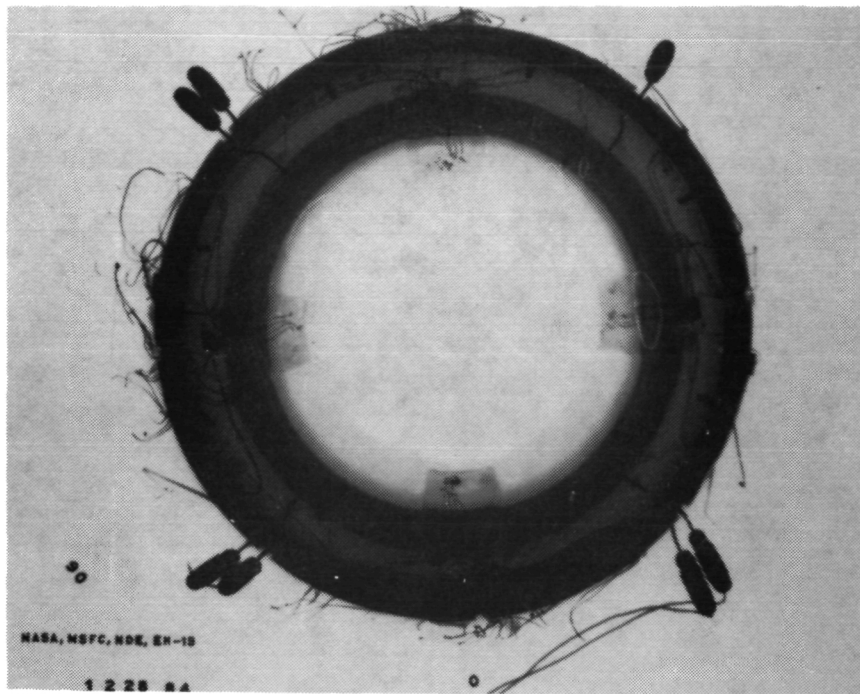
Resolution of the above indications was possible using the x-ray film. Regions of large bond gap (carbon-phenolic to carbon-carbon), potential hot gas flow and density variation were noted (Fig. 8).

Figure 8. Axial RT of CCT-1. (While resolution in x-ray print is inferior to characterized film, several indications are visible, including instrumentation, flow patterns, and bond gap.)

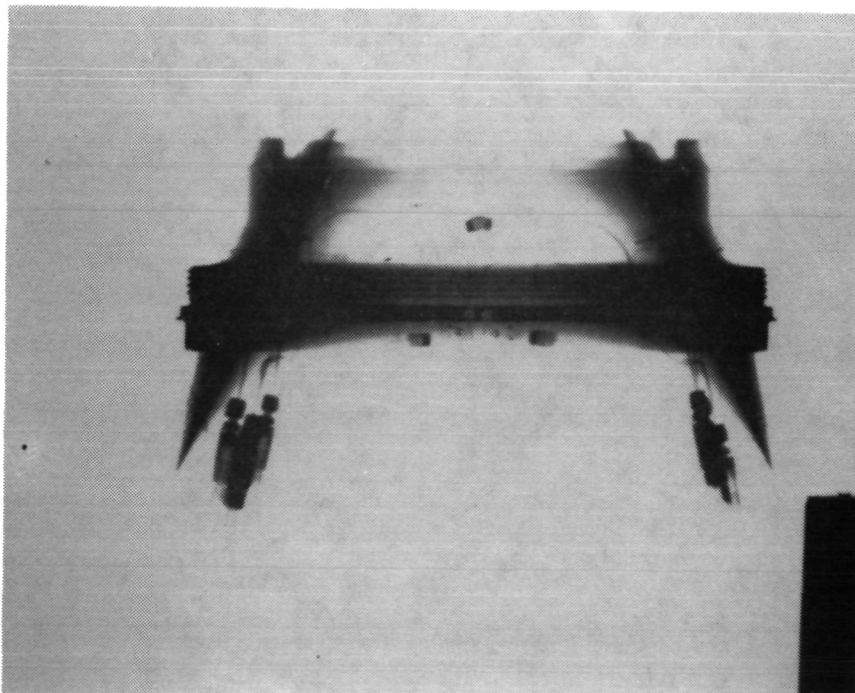
Figure 9. Tangential RT of CCT-1/MTI/E. (Pressure transducers, instrumentation, and o-ring bond gap, while visible, lack clarity. View is 180 deg true tangential.)

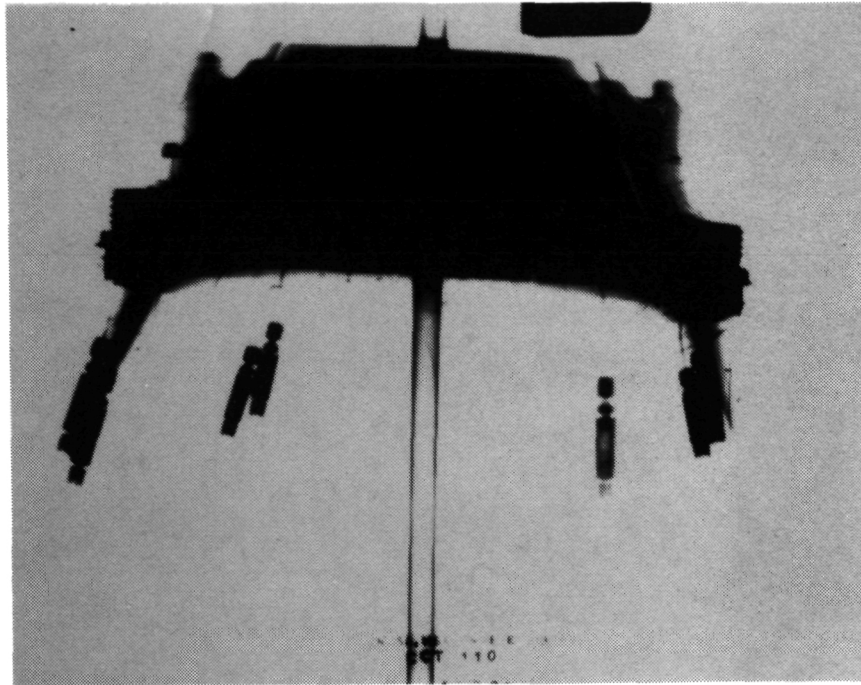
Figure 10. Tangential RT of CCT-1/MSFC. (Post-test RT of CCT-1 supported by CT alignment fixture. Note circumferentially non-uniform gap. View is 110 deg true tangential.)

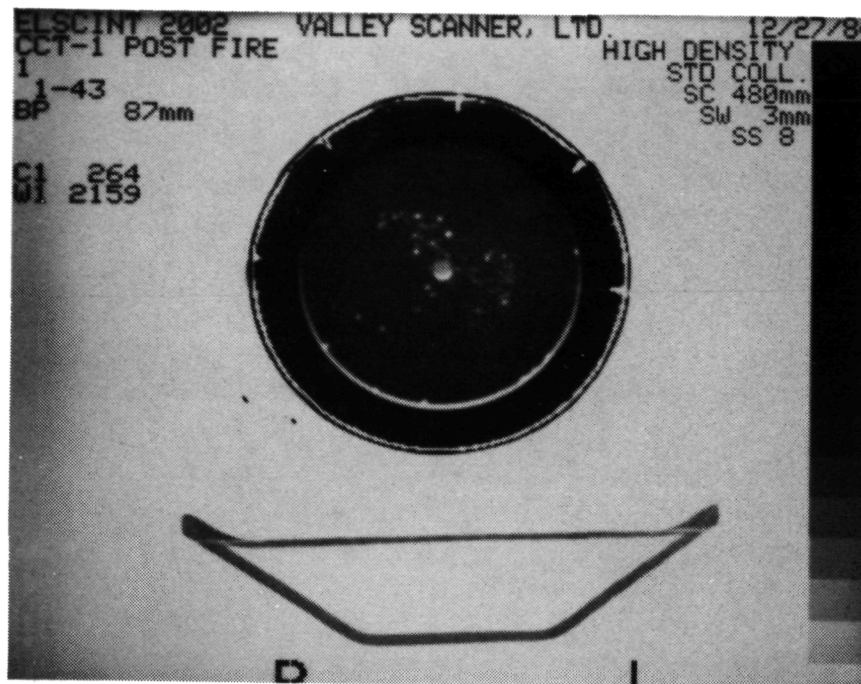
The CT data on the exit cone assembly provided information delineating the suitability and limitations of the CT technique to exit cone assemblies. The STAR 48 assembly has a titanium ring attach fitting on the exterior of the carbon phenolic insulator (Fig. 7). The high density of this ring caused high scattering and anomalous indications in the slices resolved at its location (Fig. 12).

Figure 12. CCT-1 CT scan anomalies. (Strobing effects from pins and titanium adaptor are evident. High-density indications in interior are due to alignment fixture artifacts.)

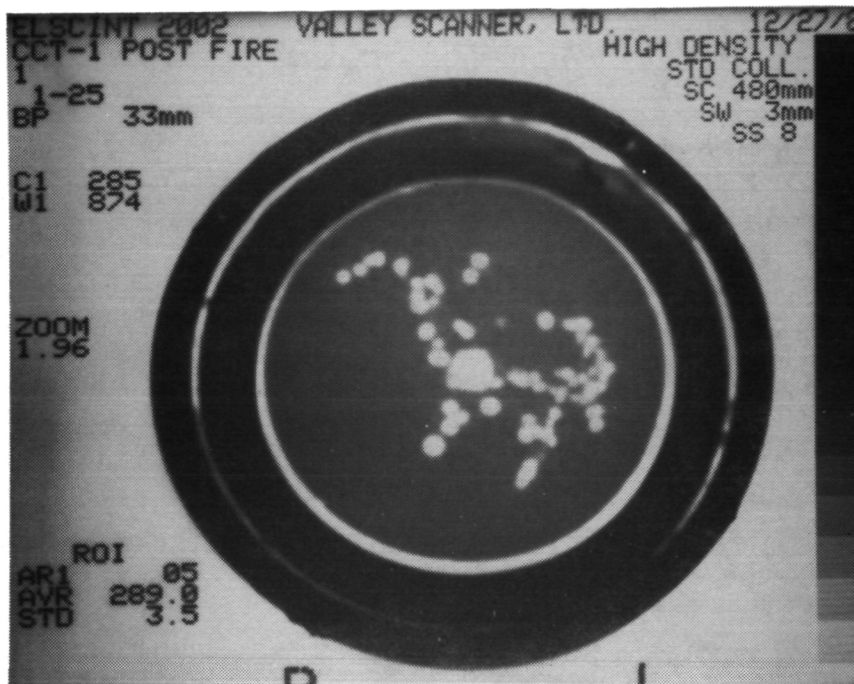
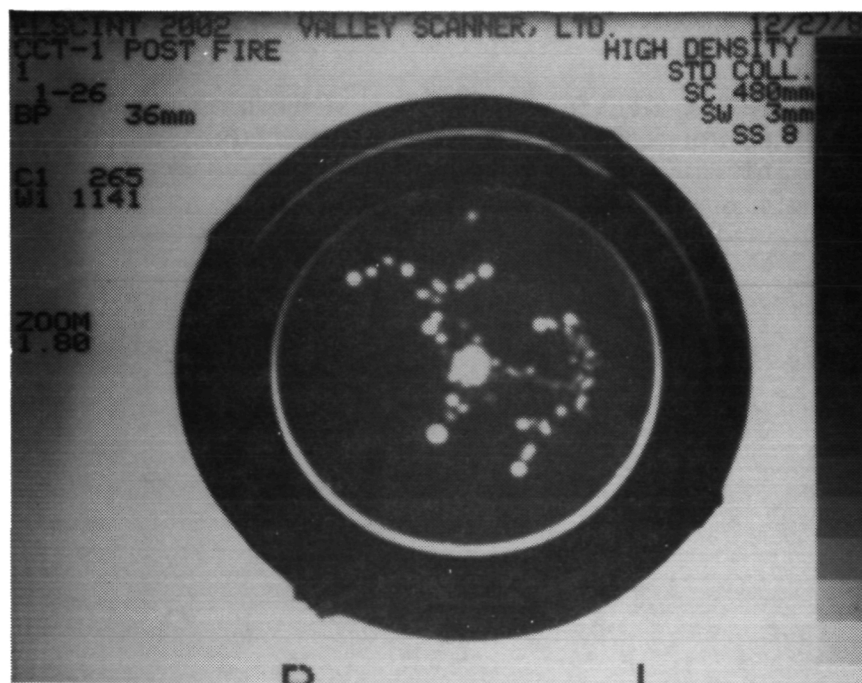
Figure 13. CCT-1 CT scan/bond gap. (Circumferentially non-uniform bond gap is evident in this thread region slice. Note flow region at 20 deg position.) (a) at 33 mm. (b) At 36 mm.

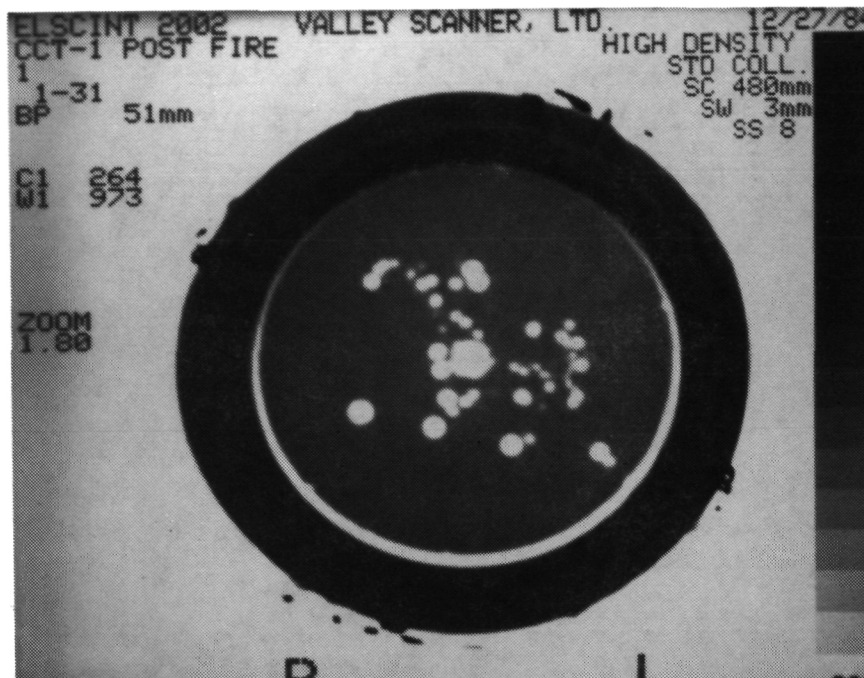
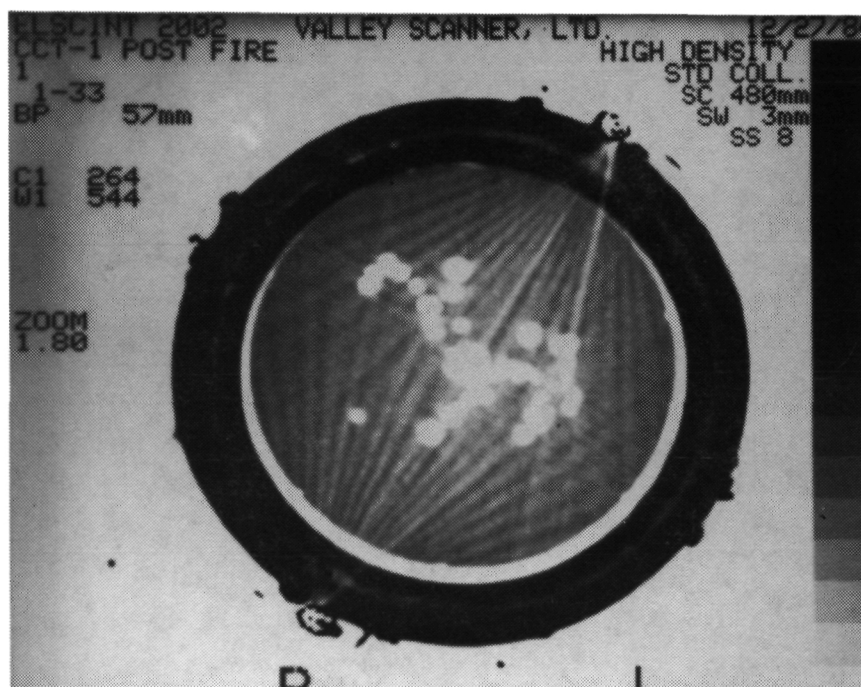
A somewhat less clear indication of the non-uniformity of the bond gap is visible farther down the assembly [Fig. 14(a)]. It must be noted that, as was the case for the x-ray data, the figures display less clarity than the CT data. Finally, a display of the strobing effects caused by high density objects is presented [Fig. 14(b)].

Figure 14. CCT-1 CT scan/bond gap. (a) While not as evident as in forward thread regions, bond gap non-uniformity is still present. (b) Strobing and high-density inclusions in the bond gap.

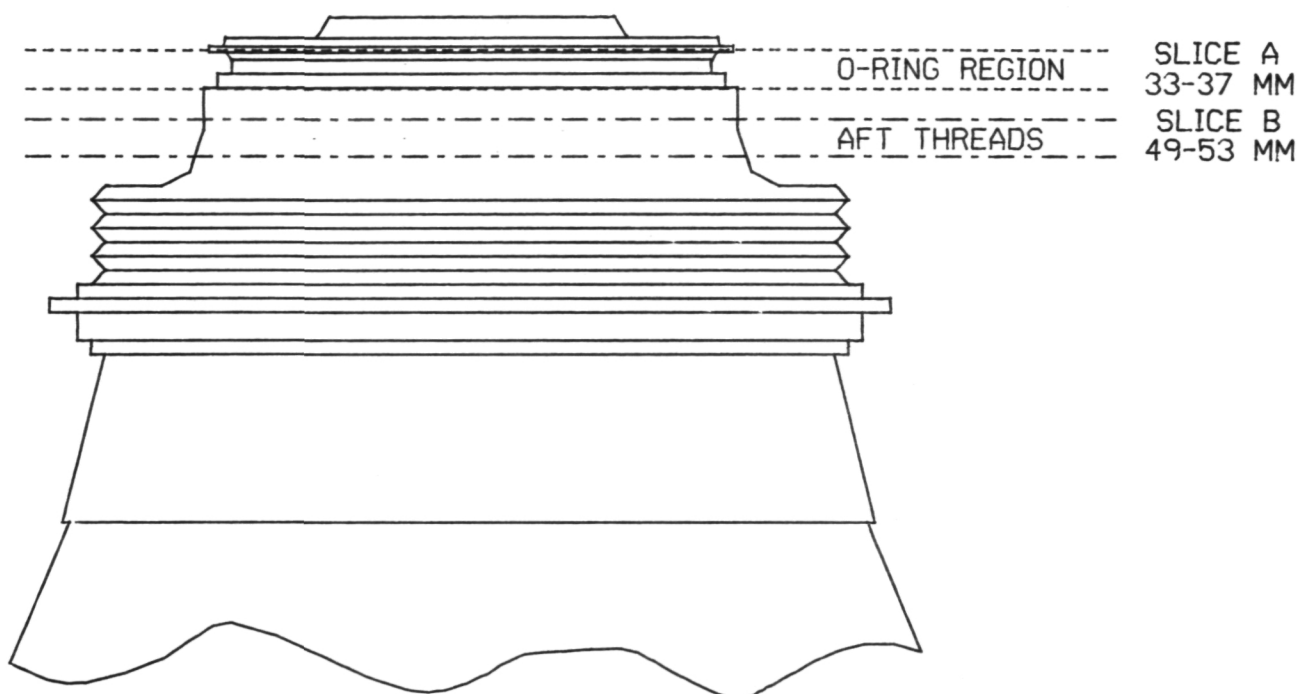
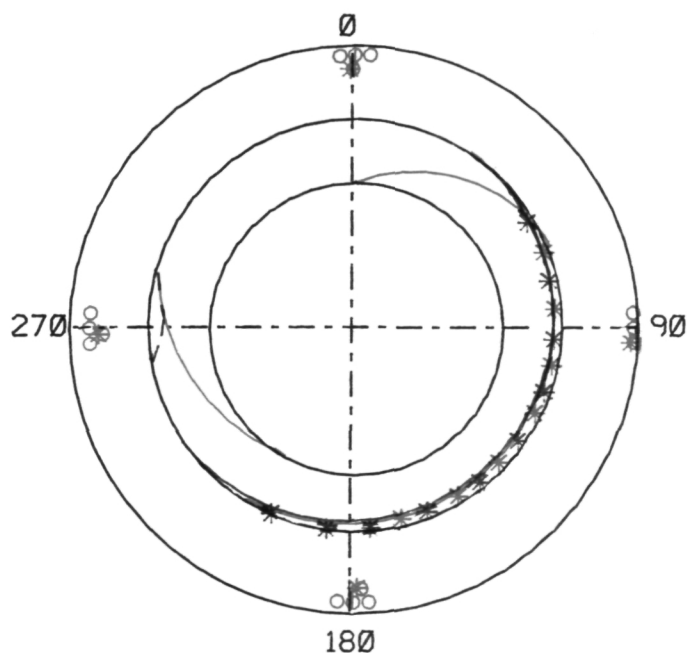
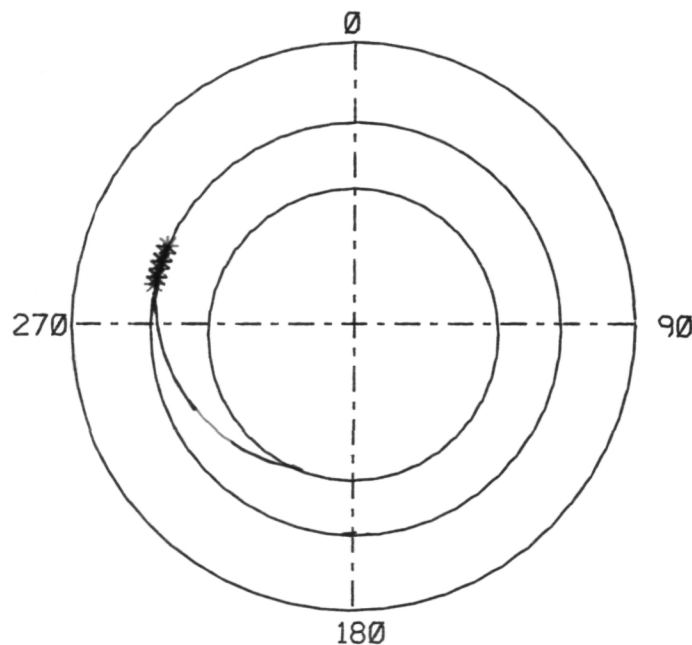
The results of the correlation effort for CT and x-ray data are presented (Fig. 15). While the x-ray technique for transfer of tangential indications to axial slices is tedious and labor-intensive, the CT indications are found to be in excellent agreement. Further, it may be seen that the two techniques are not redundant, but rather complementary. The x-ray indicates a region of potential flow not noted on the CT. After this indication was determined, a reinvestigation of the CT did reveal a slight anomaly at the cited location. However, as this investigation was centered upon correlation of initial indications, determined through distinct methods, these data were not included in the correlation maps. CT was able to delineate planar locations that the x-ray was unable to resolve. Finally, although both techniques were able to resolve the presence of the instrumentation, the x-ray method provided additional information on the exact location of the high density probes.

Figure 15. CCT-1 data correlation map. (The correlation for the anomaly types is clearly indicated.)

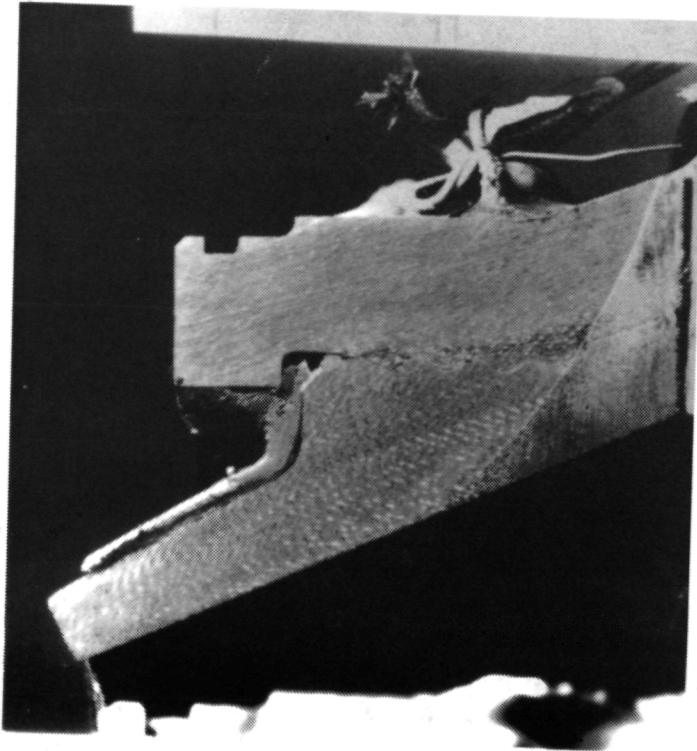
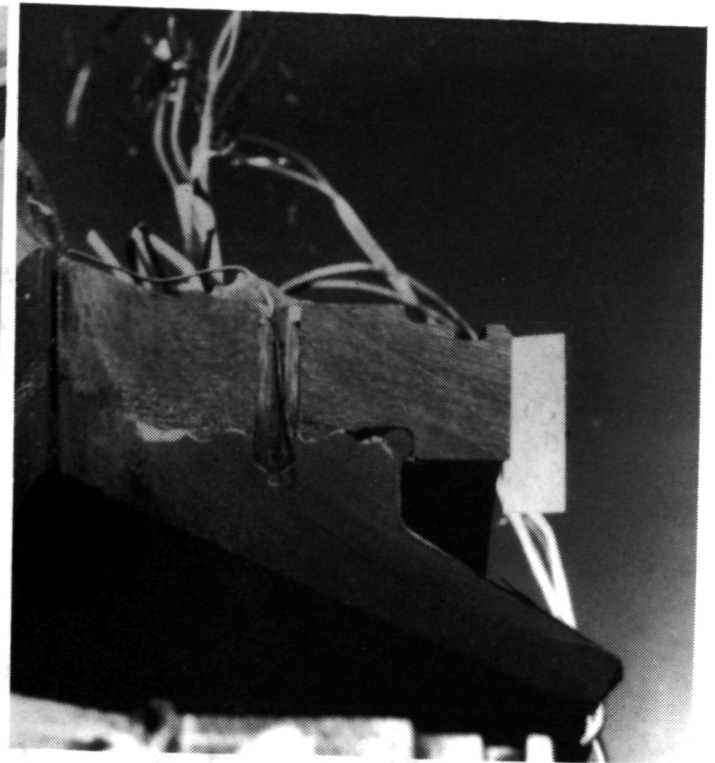
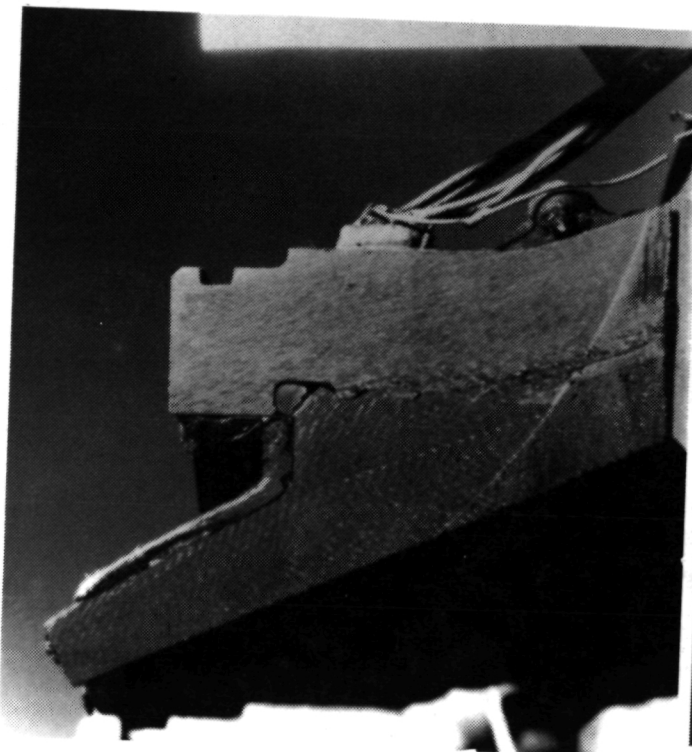
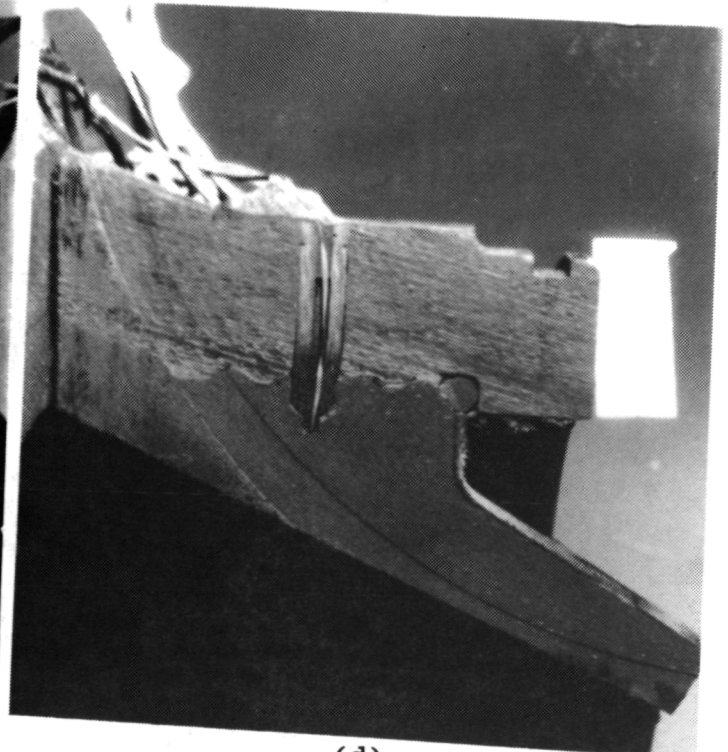
Figure 16. Cross-section of CCT-1/forward segment. (Visual observations reveal circumferentially non-uniform O-ring gap, varying amounts of adhesive in the thread region, and a slight axial shifting of the exit cone.)

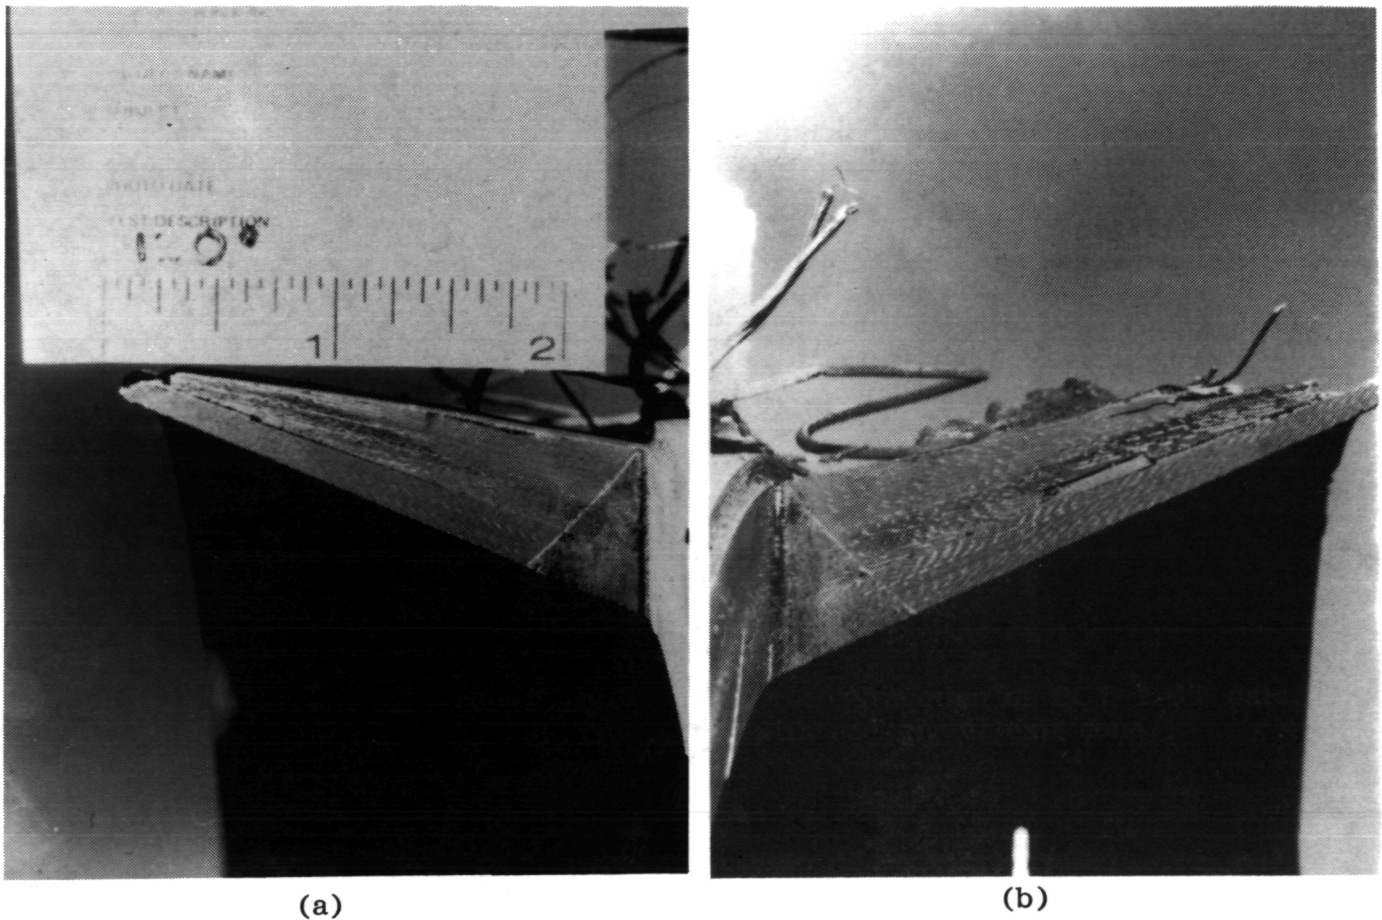
Figure 17. Cross-section of CCT-1/aft segment. (Visual observations reveal instrumentation sites, delamination region (b), and char indications.)

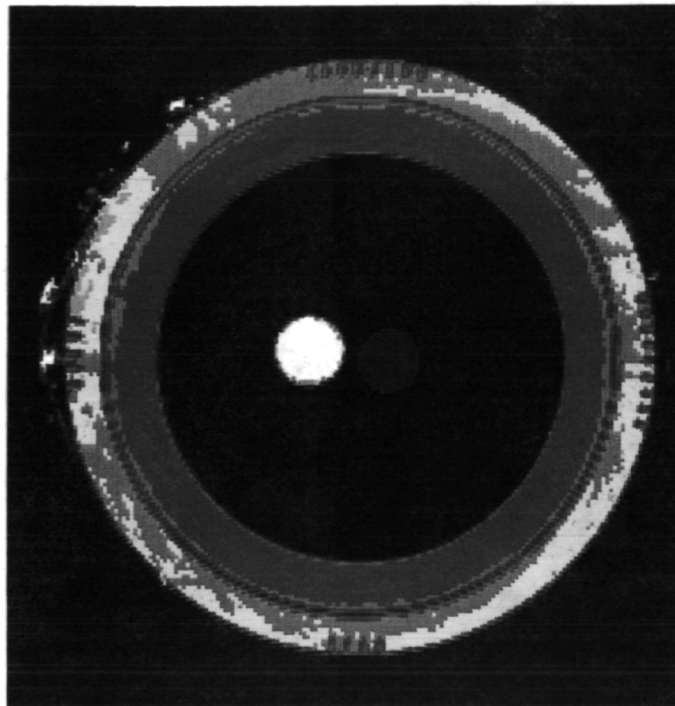
Figure 18. CCT-2 CT/preliminary. (MSFC reconstruction of CCT-2 CT data. Note non-uniform bond, consistent with cocking of exit cone.)

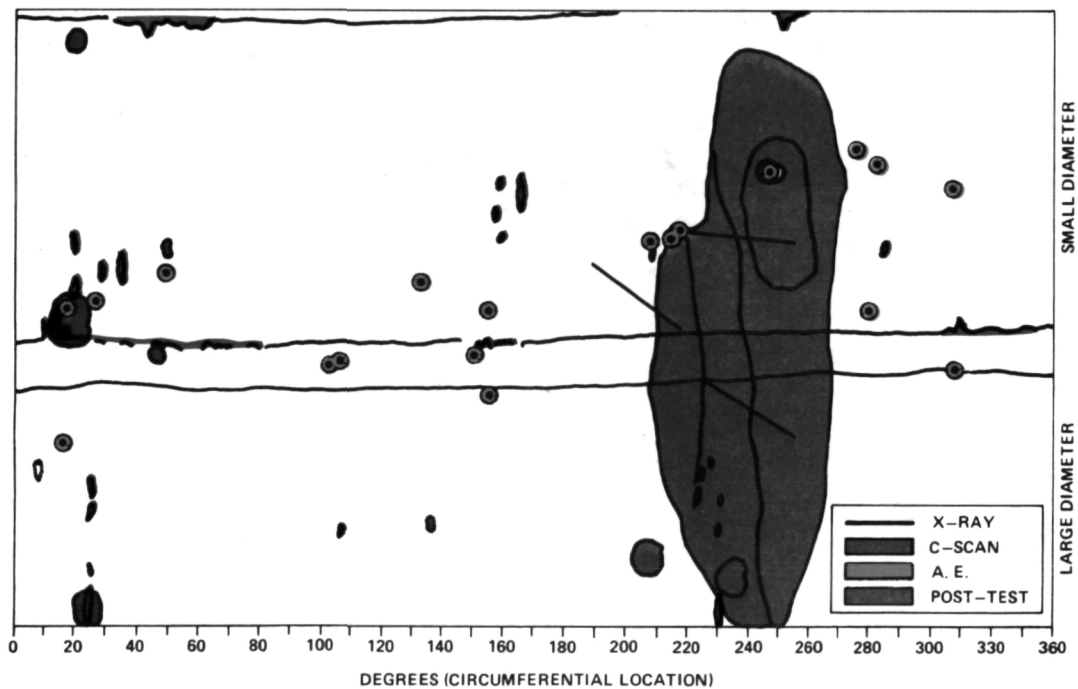
The hydrobuckled section was evaluated with visual, x-ray and ultrasonic techniques. A complete mapping of these data are presented (Fig. 20). The green indications are the regions of high attenuation located through ultrasonic inspection pre-test. The straight black lines located between 200 and 260 deg are the x-ray indications typically termed planar indications. The two black dots at 210 and 240 deg are x-ray indications for a high density inclusion and a missing fiber region, respectively. The circles represent the acoustic emission data taken during the test. The blue regions in Figure 20 represent the visual observations post-test (Fig. 21). The regions at 20 deg, above and below the stiffener ring, the regions at the sites of the x-ray indications (210 and 240 deg), and the small region at 250 deg represent regions in which surface indications came into being post-test. These surface markings were either cracks/surface crazing indications (locations at 20 and 250 deg), or surface discolorations (locations at 210 and 240 deg).

Figure 20. NDE correlation map/hydrobuckle test. (Green indications - UT scan regions of high attenuation; straight black lines located at 200 deg and 260 deg x-ray planar indications; two black dots at 210 deg and 240 deg - high-density inclusion/missing fiber region/ red circles - acoustic emission data; blue regions - post-test observations.)

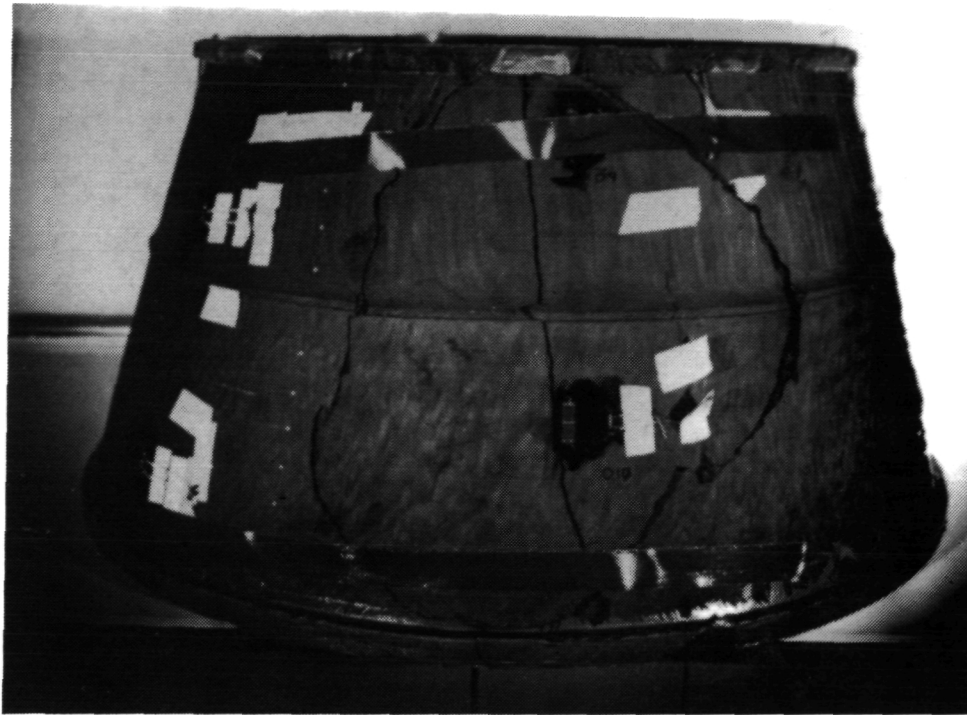
Figure 21. Post-test cone. (Buckled region of test cone. Note surface crazing in region left of buckle center-line below stiffener ring.)

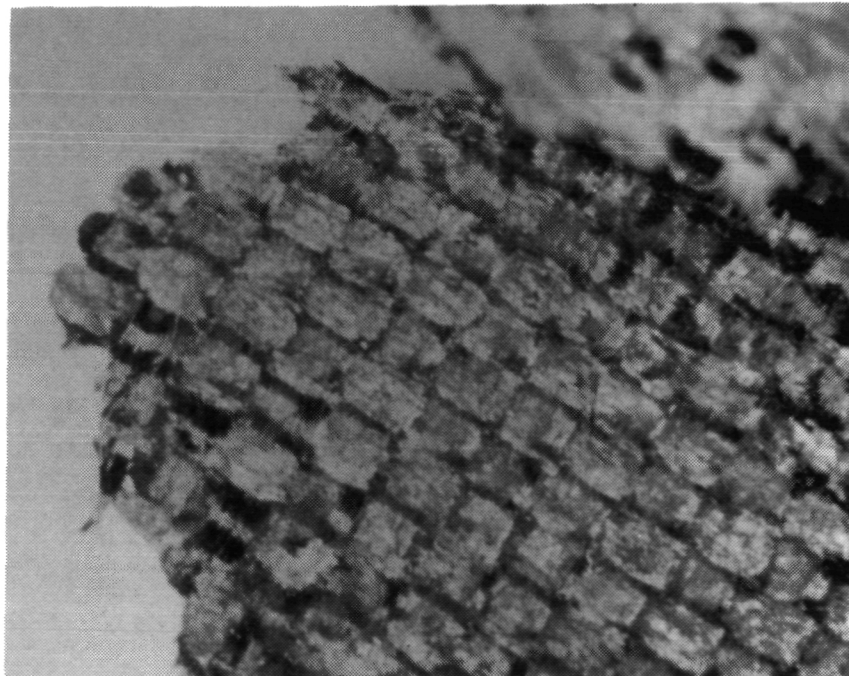
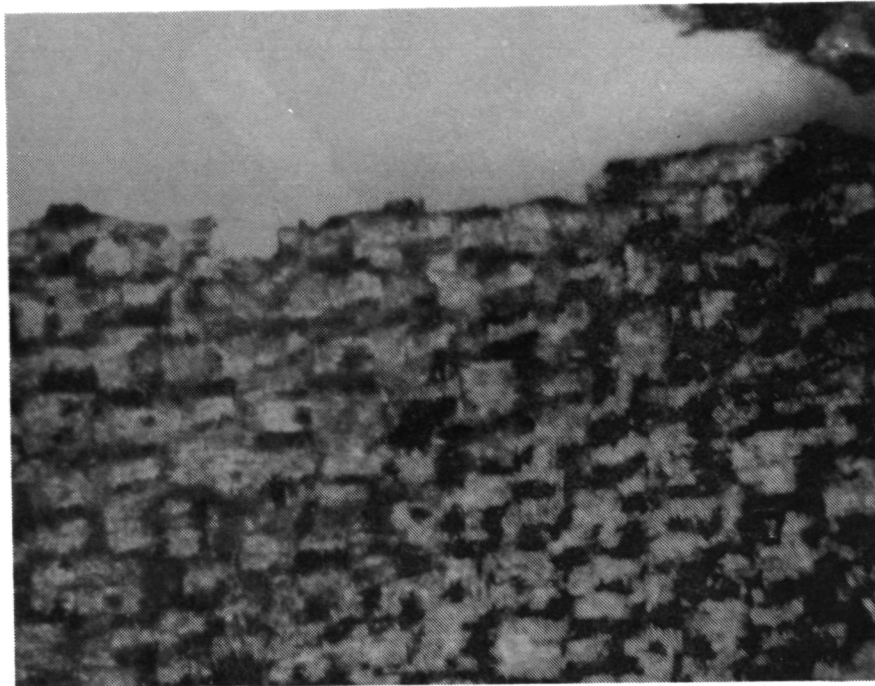
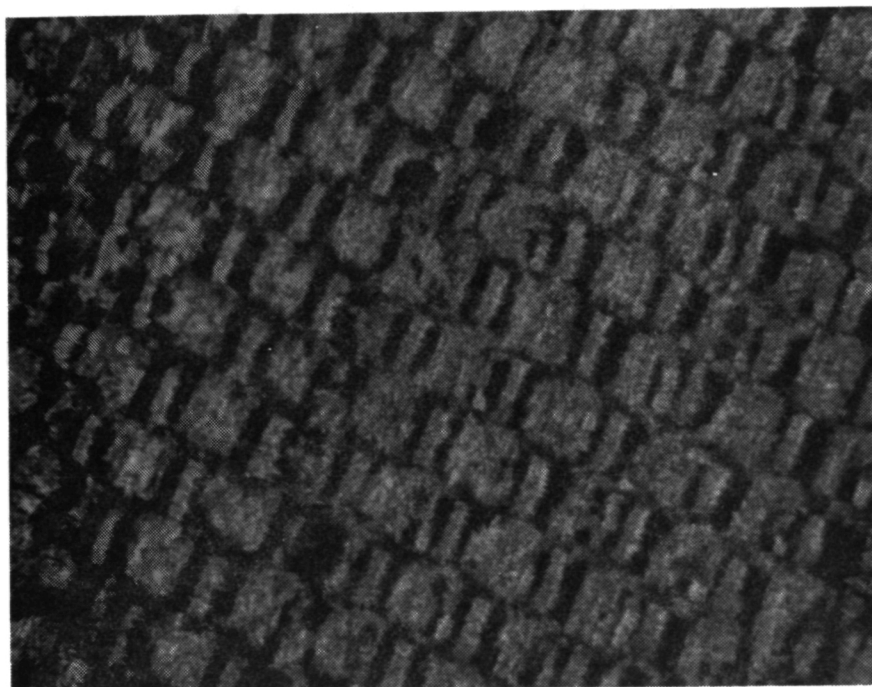
Figure 22. 220 deg region micrographs. (a) Crack juncture outside of matrix-full region; fiber bundle surfaces not evident. (b) Crack juncture inside; rougher surface appearance, some fiber bundle surface visible. (c) Dry ply region below stiffener ring cracks surface; high incidence of visible matrix-poor clean fiber bundles.)

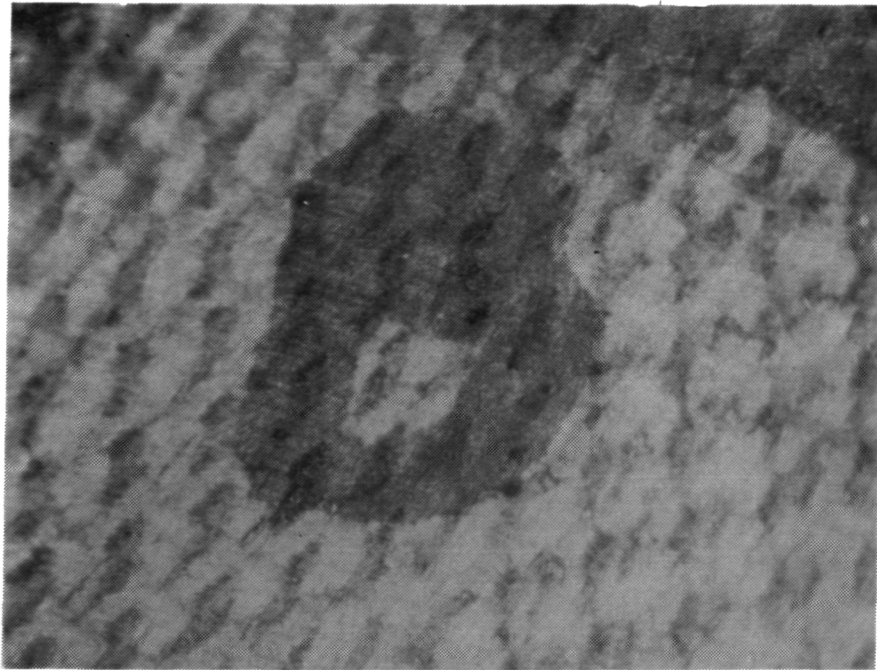
Figure 23. 240 deg surface indication. (Surface indication is clearly shallow and does not appear to affect internal fibers.)

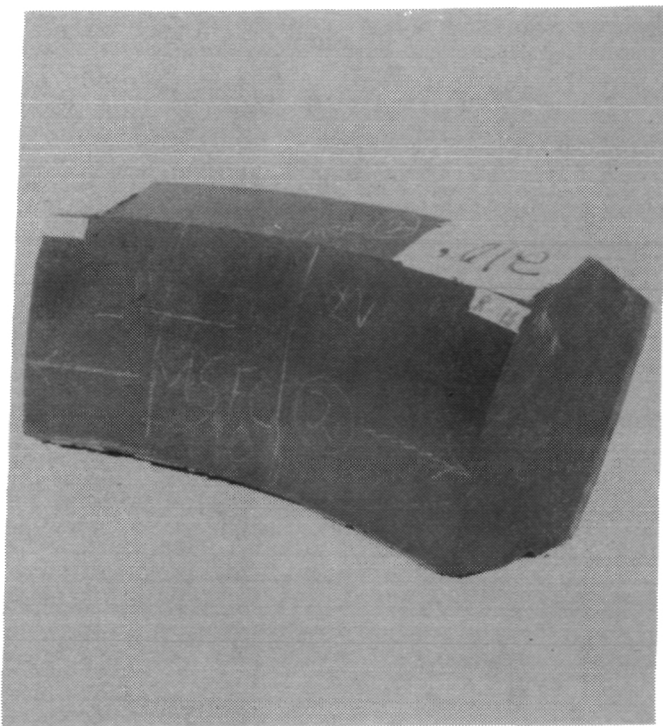
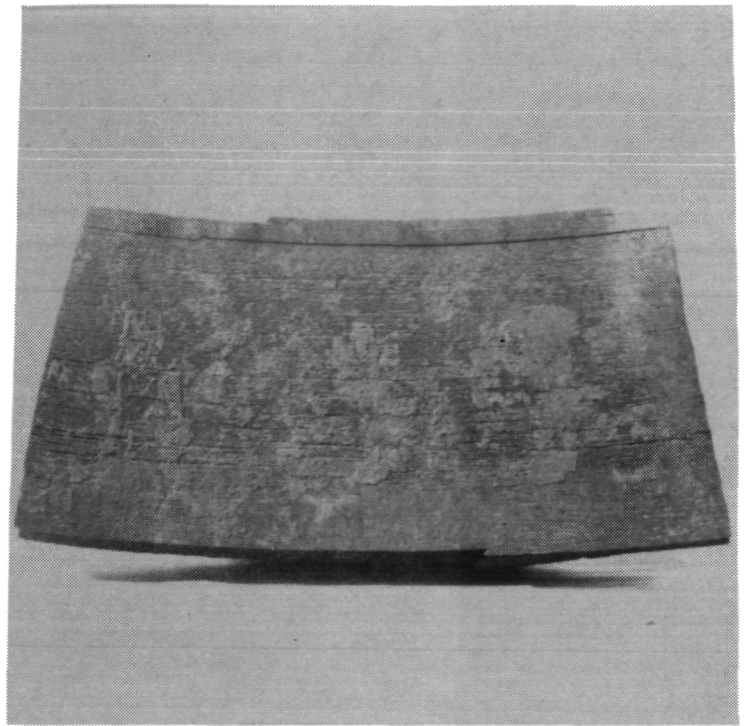
Figure 24. Representative SRM segment samples. (a) Unfired segment marked for test. Light region on OD is composed of silica phenolic. (b) Fired SRM segment. Note char and delamination regions.
